Manhole Inspection Summary

Manhole # S33CC_015MH

Inspection ☐ Is Incomplete Rating: **3) Fair**

Location Address: **1023 N. Charles**

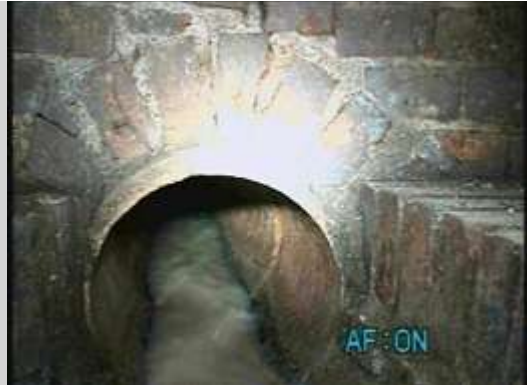
12 O'Clock Outflow

8 in. Circular Gravity Sewer
Pipe Out @ 12 O'Clock

Deposits: ☒ None ☐ Mud ☐ Sludge ☐ **Debris** ☐ Grease

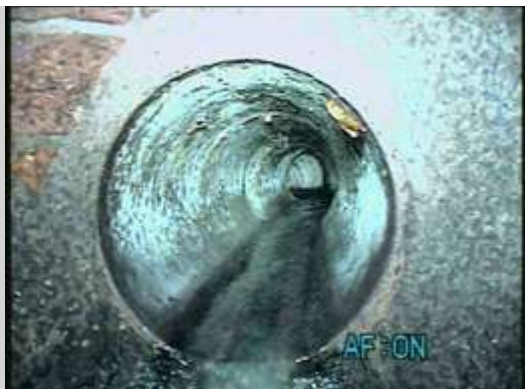
7 O'Clock Inflow

8 in. Circular Gravity Sewer

Pipe In @ 7 O'Clock

Deposits: ☒ **None** ☐ Mud ☐ Sludge ☐ Debris ☐ Grease

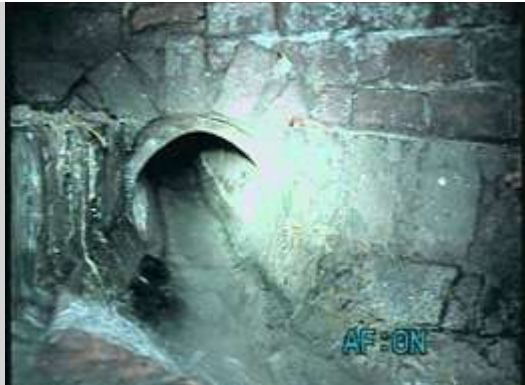
9 O'Clock Inflow

8 in. Circular Gravity Sewer
Pipe In @ 9 O'Clock
